# Severe Metallosis in an Isoelastic Hip Prosthesis

P Thiagarajan, S Das De

**Severe black staining due to metallic wear debris has been reported in metal-on-metal hip prosthesis<sup>(3)</sup>. This problem is not commonly seen because of the popular use of metal-on-polyethylene component and has not been previously reported with the use of isoelastic femoral prosthesis. We report a case of severe metallosis in an isoelastic prosthesis, four years after implantation.**

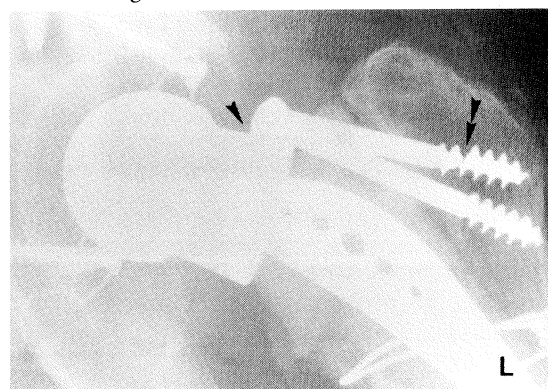
Clinical examination revealed a left hip flexion of 50° from the neutral position. Both internal and external rotation were 15°. There was very minimal abduction and adduction present. He had an antalgic gait with gluteal wasting. The Trendelenburg test was positive. X-rays of the left hip (Fig 1) revealed a broken cancellous screw from the femoral component fixation. There was a clear zone of lucency between the femur and the femoral component compatible with loosening.

**Fig 1** – X-ray of an isoelastic hip showing the screw heads to be in contact with the femoral prosthesis (single arrow) and a broken screw (double arrow).

In our patient, the toggling effect of the loose femoral component caused one of the cancellous screws to sustain a fatigue fracture. This resulted in the screw head abutting against the femoral head causing the progressive release of metallic wear debris. The metallic wear debris could have hastened the process of aseptic loosening by being trapped in the implant-bone interface. Based on our observation of metallic debris in the femoral canal, we postulate that the aseptic loosening process could have been, at least partially, hastened by the broken screw.

This case highlights the problem of proximal anchoring screw in implants designed to be used without bone cement. In such a clinical situation, we recommend that the broken screw be removed as early as possible to prevent severe metallosis with its complications.

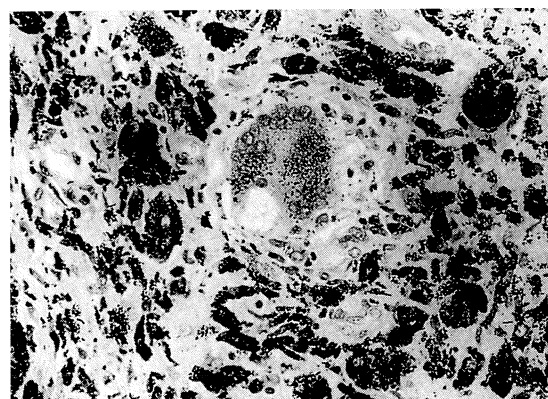
**Fig 2** – Photomicrograph (H&E stain) showing synovial hypertrophy with abundant dark granular material (Mag. x 40)

Histology (Fig 2) showed marked proliferation of synovial lining cells covered with fibrin and necrotic debris containing abundant dark granular material. There was no evidence of sepsis or malignancy. The retrieved femoral component was stained black due to the debris. The metallic head clearly revealed the site of abrasive wear.
