Clinics in diagnostic imaging (167)

Total shoulder arthroplasty glenoid component loosening with secondary rotator cuff failure.

Keywords: dual-energy computed tomography, prosthesis loosening, rotator cuff failure, shoulder arthroplasty

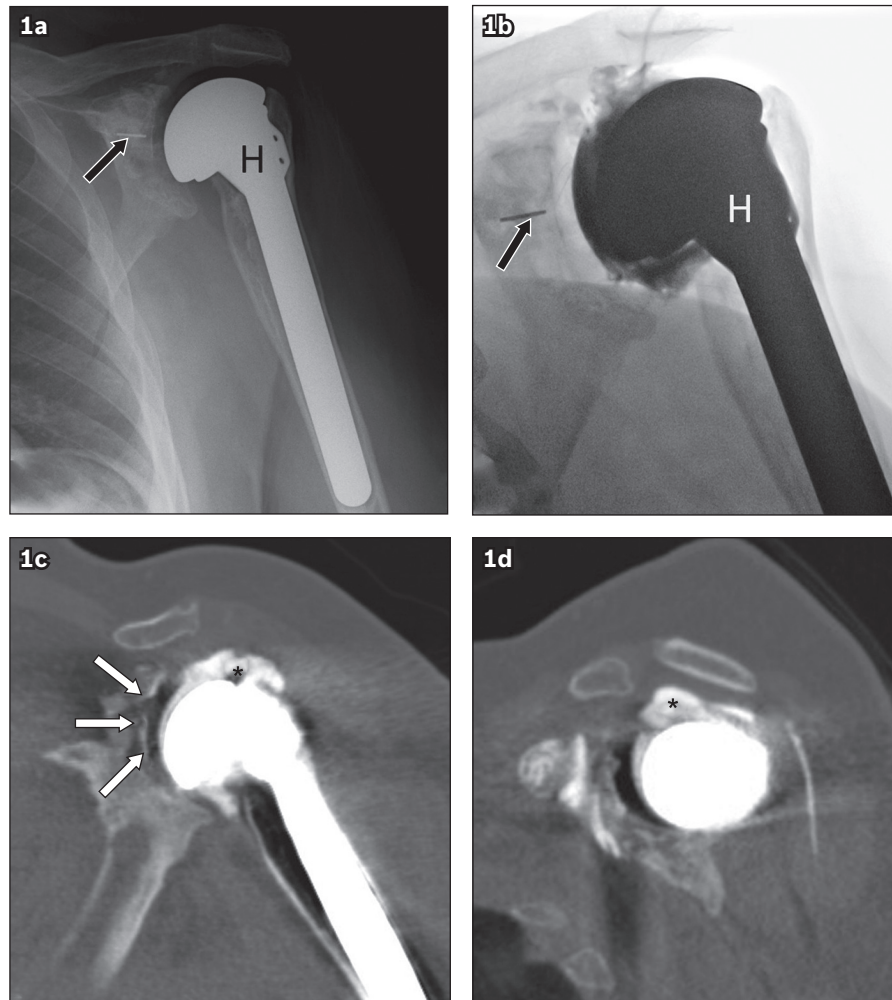
Fig. 1 Anteroposterior (a) radiograph and (b) fluoroscopic arthrogram image of the left shoulder. (c) Coronal and (d) sagittal monoenergetic 80 keV dual-energy computed tomography images of the left shoulder acquired immediately after the left shoulder arthrogram.

stiffness, which limited her activities of daily living. A physical examination revealed significant reduction in motion of the left shoulder, which included limitation of active forward flexion of about 40°. There was also difficulty in initiating shoulder abduction. Radiographic (Fig. 1a) and arthrographic (Fig. 1b) assessments of the left shoulder were performed. These were followed by dual-energy computed tomography (DECT) of the left shoulder, which was performed without intravenous contrast immediately following the left shoulder arthrogram (Figs. 1c & d). What do these images demonstrate? What is the diagnosis?

Anteroposterior radiography (Fig. 1a) and the fluoroscopic arthrogram image (Fig. 1b) of the left shoulder demonstrate a cemented left anatomic total shoulder arthroplasty, which consists of the humeral component (H) and a radio-opaque marker (black arrows) on the central peg of the radiolucent glenoid component. No significant periprosthetic lucency suggesting loosening or a periprosthetic fracture is identified on the radiograph. There is no clear insinuation of contrast into the bone-cement or implant-cement interface in the fluoroscopic arthrogram image. Coronal (Fig. 1c) and sagittal (Fig. 1d) monoenergetic 80 kiloelectron-voltage (keV) DECT images of the left shoulder, obtained immediately following the arthrogram, reveal a dense sliver of intra-articular contrast insinuating into the implant-cement interface of the glenoid component (white arrows), as well as a large contrast-filled gap (*) at the expected location of the supraspinatus tendon; the latter is in keeping with a complete tendon tear.

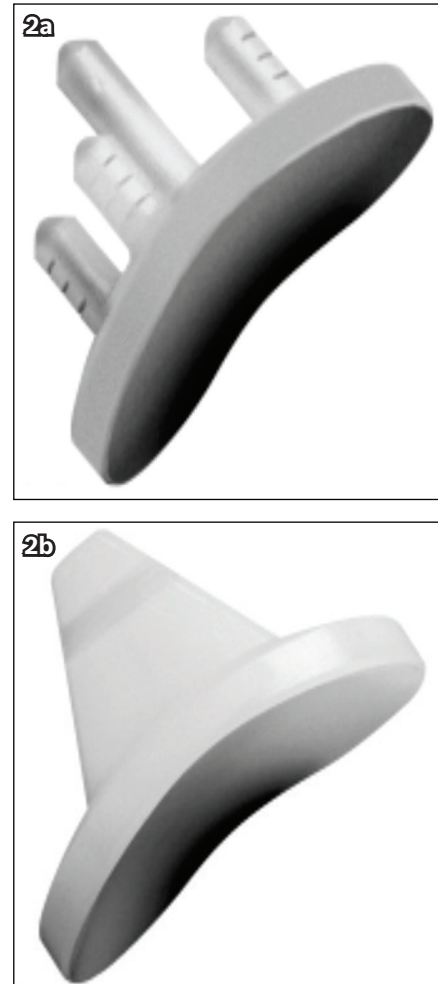
Fig. 2 Illustrations show the (a) pegged and (b) keeled glenoid components used in shoulder arthroplasty (reproduced with permission from Lazarus et al⁽⁴⁰⁾).

Our case involved an anatomic total shoulder arthroplasty, which is most commonly performed for degenerative osteoarthritis in patients older than 60 years, and required an intact rotator cuff. The humeral component is a minimally constrained anatomic implant consisting of a hemispherical metal articular surface and a cemented or press-fit stem. This articulates with a radiolucent polyethylene glenoid component. The central peg of the glenoid component contains a radio-opaque marker.⁽⁵⁾ Pegged glenoid components (Fig. 2a) are now favoured over their keeled counterparts (Fig. 2b) due to the proposed benefits of more uniform stress distribution to the

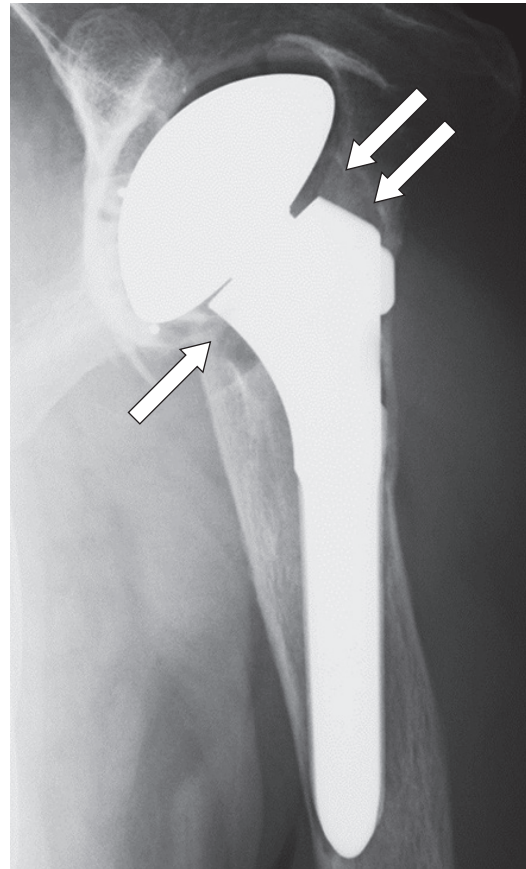
Fig. 3 A 79-year-old man with prior anatomic total shoulder arthroplasty. Left shoulder radiograph shows periprosthetic lucency (arrows) related to the humeral component, which is in keeping with loosening.

The most commonly encountered complication of anatomic total shoulder arthroplasty is loosening of the glenoid component, which occurs in up to 39% of patients following arthroplasty.⁽⁷⁾ Preliminary imaging evaluation of the painful shoulder following an arthroplasty is typically performed using plain radiographs, where glenoid component loosening manifests as glenoid component migration, tilt or periprosthetic radiolucency measuring more than 1.5 mm in thickness.^(7,8) The grading of periprosthetic radiolucency for keeled glenoid components was first described by Franklin et al (Table I),⁽⁹⁾ and subsequently modified by Lazarus et al to grade periprosthetic radiolucency for pegged glenoid components (Table II).⁽¹⁰⁾ Other previously described complications of anatomic total shoulder arthroplasty include loosening of the humeral component (Figs. 3 & 4), glenohumeral instability, periprosthetic fracture (Fig. 4), dislocation (Fig. 5), infection (Fig. 6), rotator cuff failure, neural injury and deltoid muscle dysfunction.⁽¹¹⁾

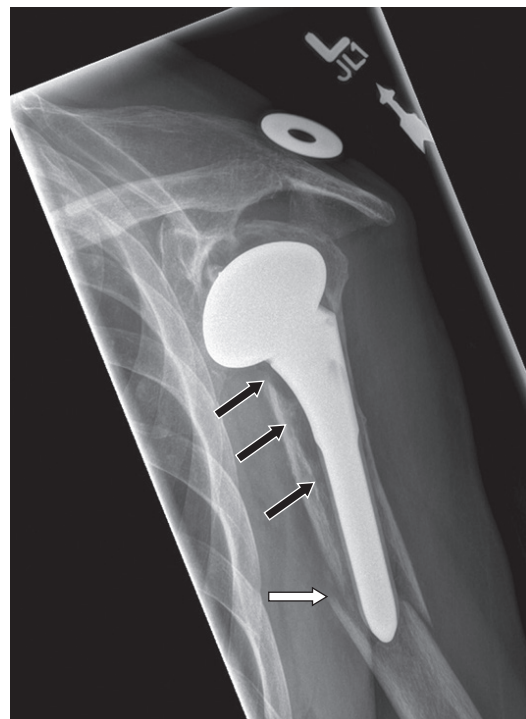
Fig. 4 An 81-year-old man with acute chronic left shoulder pain following arthroplasty. Lateral radiograph of the proximal left humerus shows periprosthetic lucency (black arrows), which is in keeping with loosening of the humeral component, and a cortical break close to the distal tip of the stem (white arrow), which is compatible with a periprosthetic fracture.

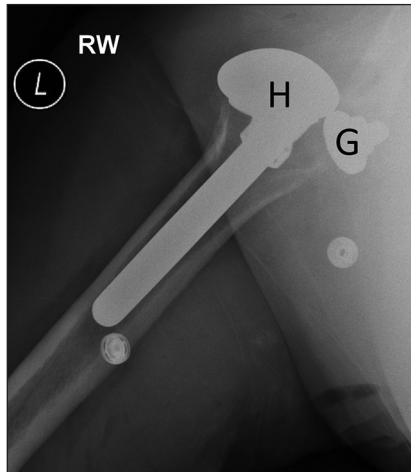
Fig. 5 A 53-year-old man with previous arthroplasty who presented with acute left shoulder pain and restricted range of motion following a fall. Axial left shoulder radiograph shows loss of congruency between the articular surfaces of the glenoid (G) and humeral (H) components secondary to acute posterior dislocation.

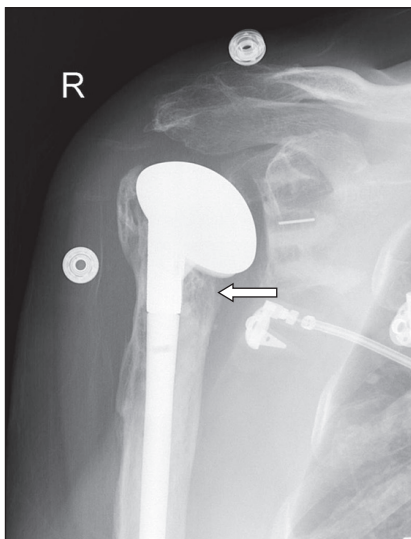
Fig. 6 A 79-year-old woman with increasing shoulder pain following shoulder arthroplasty. Anteroposterior radiograph shows increased lucency and early erosion inferior to the prosthetic humeral head (arrow). US-guided aspiration of the shoulder joint was performed and cultures of the aspirated joint fluid were positive for infection.

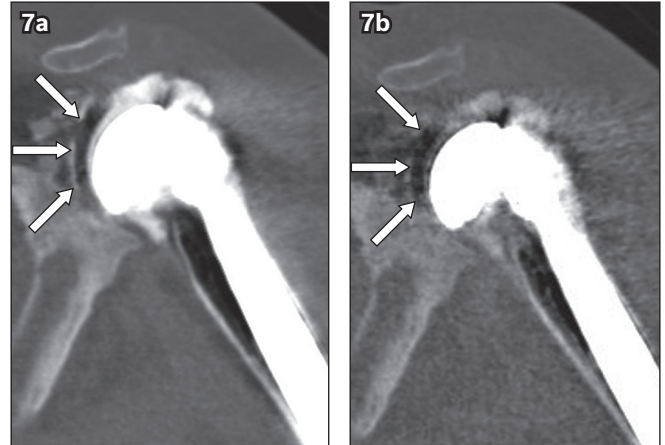
Fig. 7 Coronal monoenergetic (a) 80 keV and (b) 130 keV DECT images of the left shoulder. The sliver of contrast insinuating into the implant-cement interface of the glenoid component (arrows) is better demonstrated in the 80 keV than the 130 keV DECT image.

Utilisation of the monoenergetic spectrum of DECT to minimise beam hardening artefacts associated with implanted metal orthopaedic devices is an important application in musculoskeletal imaging.⁽¹⁷⁾ The image quality and diagnostic value of DECT imaging of orthopaedic hardware were found to be significantly improved, with minimal artefacts, at a high-energy monoenergetic 130 keV setting.^(18,19) This was seen in our case, where monoenergetic 130 keV images were superior to average weighted 120 keV images in minimising beam hardening artefacts (not shown). Of note, the monoenergetic 80 keV images better demonstrated contrast insinuation into the implant-cement interface (which confirmed the presence of glenoid component loosening) compared to the monoenergetic 130 keV images

(Fig. 7). This is due to the greater photoelectric absorption of X-rays at a lower tube voltage value by materials with large atomic numbers such as iodine, which is found in contrast medium, resulting in a greater degree of beam attenuation and increased conspicuity of contrast.⁽²⁰⁾

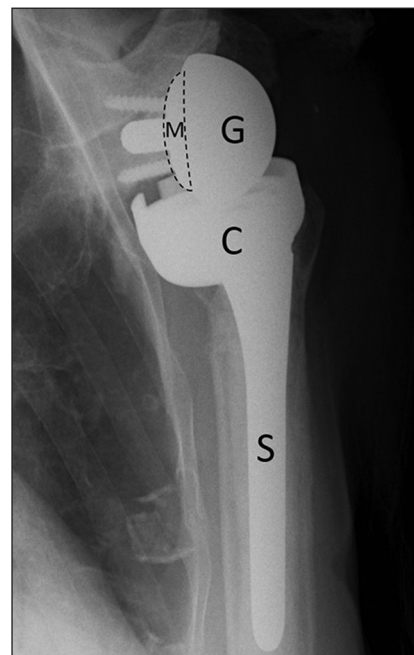
Fig. 8 Reverse total shoulder arthroplasty in a 76-year-old woman. Anteroposterior radiograph of the right shoulder shows the humeral component, which consists of a stem (S) and cup-shaped proximal portion (C). The glenosphere (G) is a hemispheric metal component that articulates with the humeral cup via a radiolucent polyethylene insert. The glenosphere is attached to a baseplate known as metaglene (area marked with broken lines; M), which is fixed on the native glenoid using screws.
