CME Article

Artifacts in mammography: ways to identify and overcome them

Singapore Med J 2006; 47(7):634-641

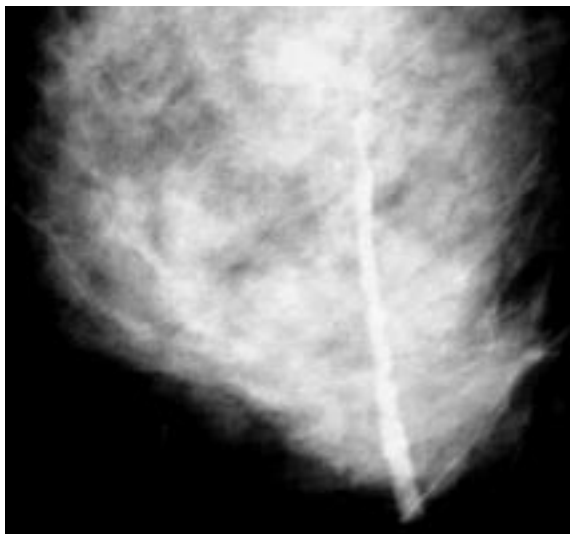
Fig. 12 A long streak of stain on the intensifying screen appears as minus density on the mammogram.

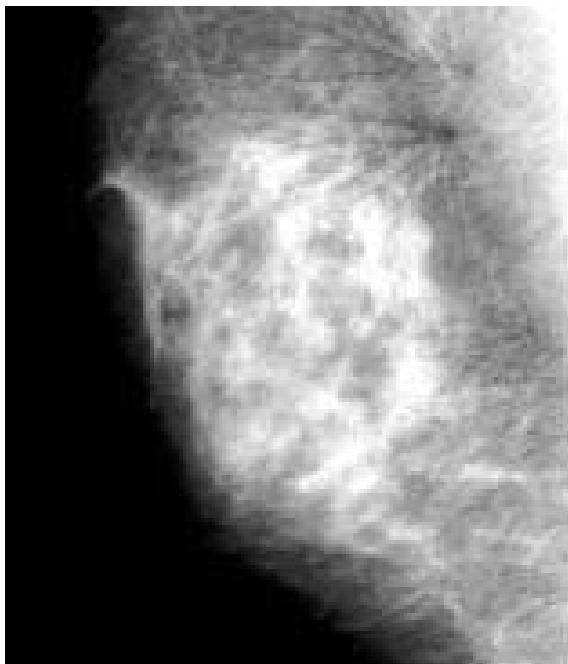
Fig. 22 Right mammogram shows a lightning-like density from a static artifact.

Artifacts that occur during processing include static artifacts, water marks, scratches, roller marks, contaminated developer, chemical residual, and incomplete fixing. Static mark artifacts appear on the mammogram as random plus-density marks that resemble ladybug, tree branches, lightning (Fig. 22), or a dark area^(1,2,8).
